# AIR PROVING GROUND

OPERATIONAL SUITABILITY TEST OF OPEN GUN PORTS FOR F-86  
AIRCRAFT

**PROJECT NO. 24913—5**

**FINAL REPORT**

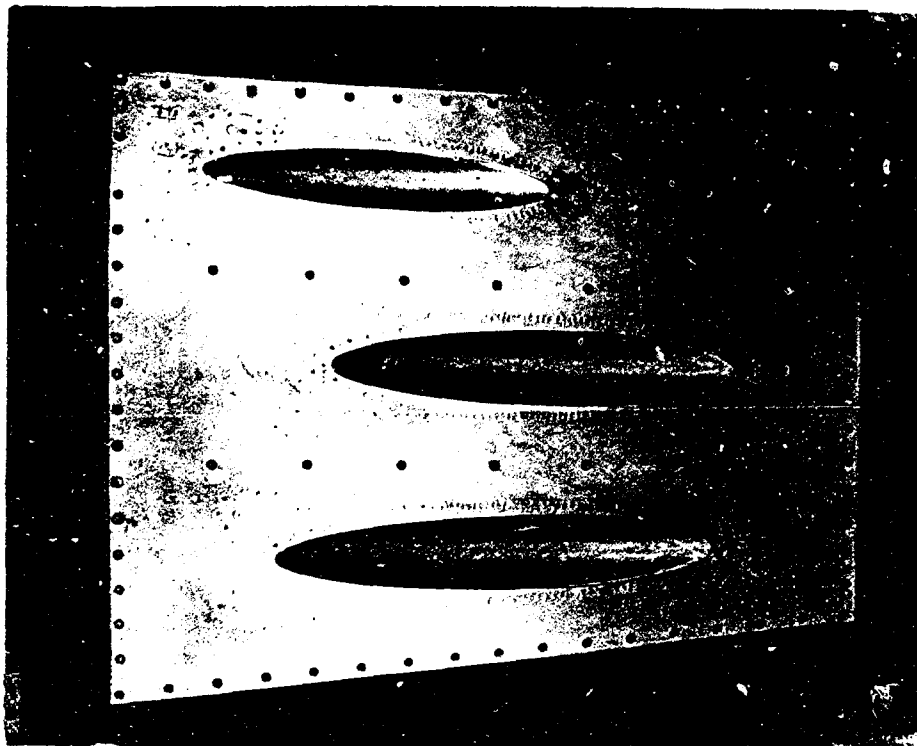
PHOTOGRAPH 1: Outside view of open gun port panel

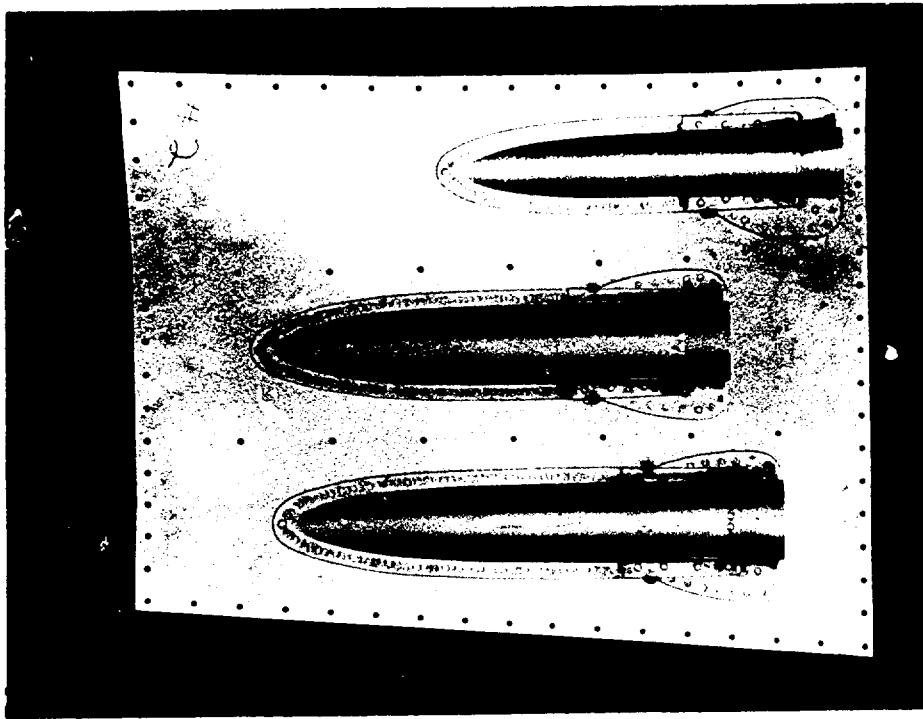
PHOTOGRAPH 2: Inside view of open gun port panel
